Subject: Site Visit Report - Johns-Manville - Waukegan, Illinois

From: Brad Bradley, Remedial Project Manager

Date of Inspection: September 10, 1986 at 10:15 a.m.

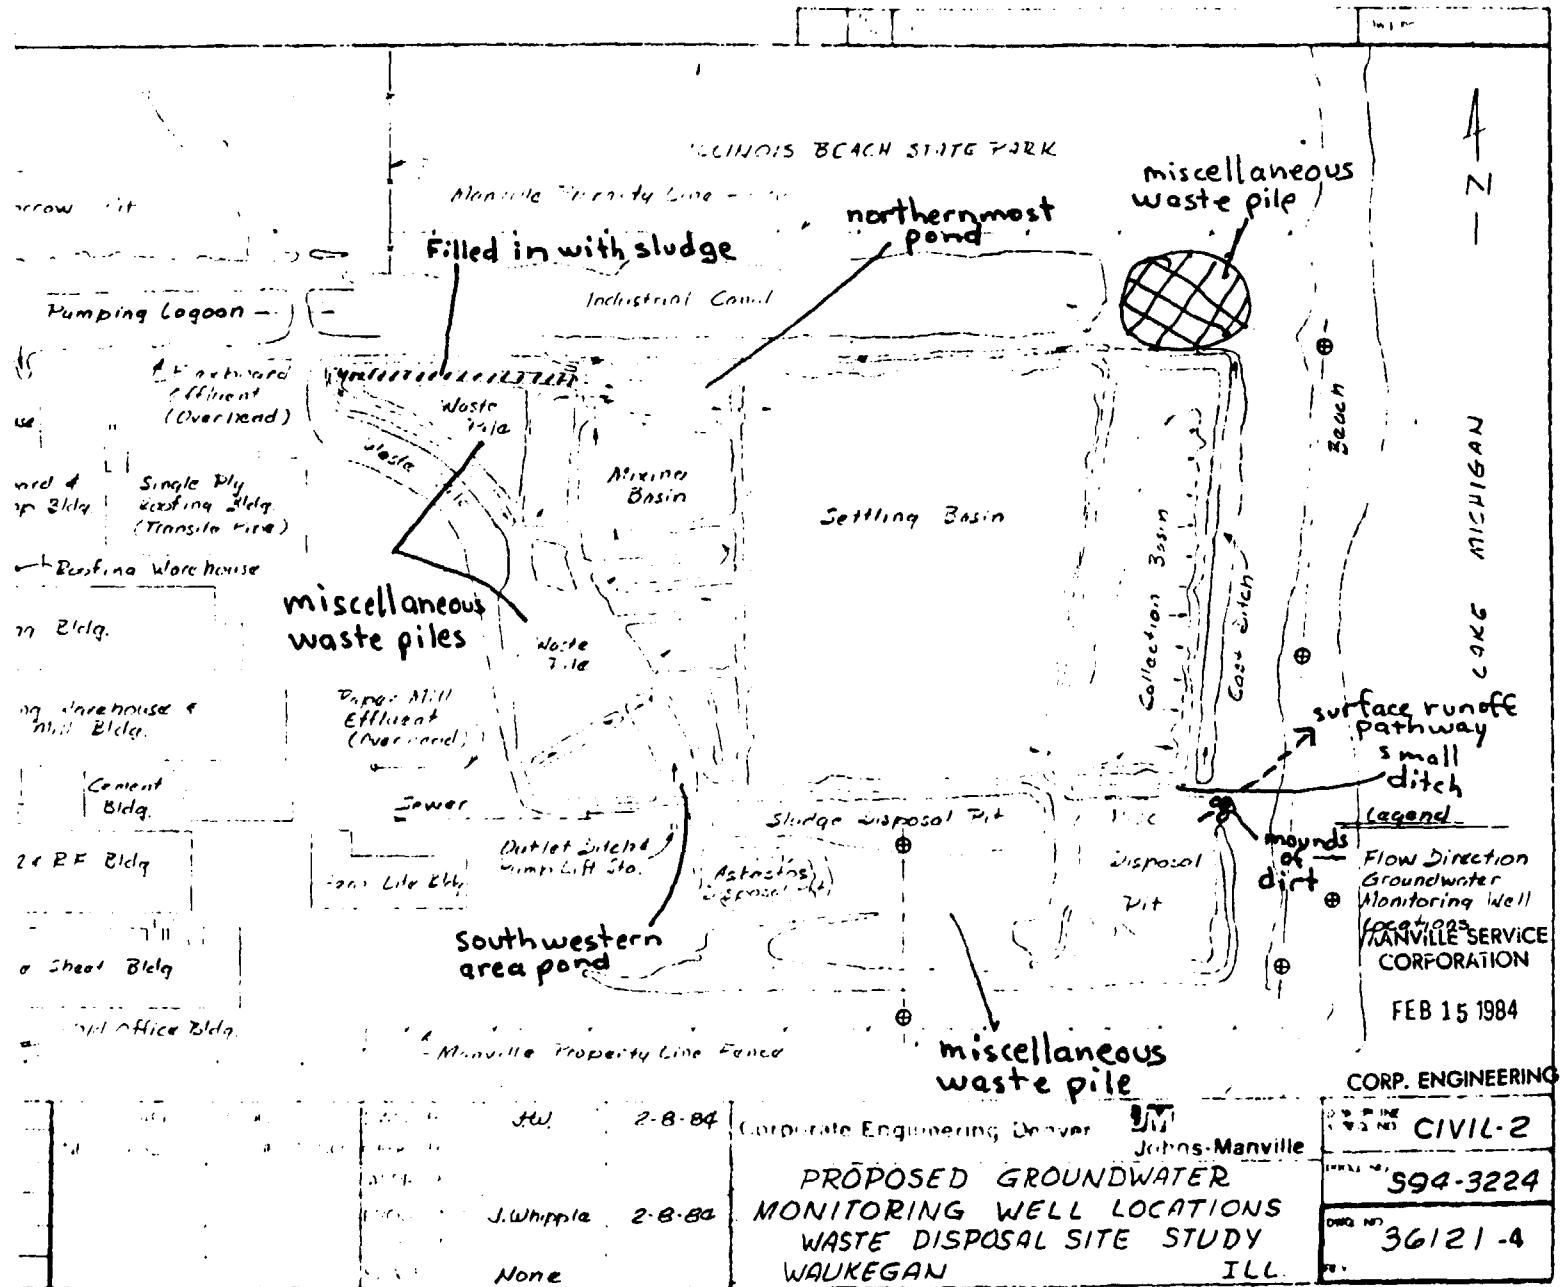
Attachment III
Site Map

Refer to Attachment III to supplement the following discussion. As noted above, Attachment III is slightly in error with respect to present site conditions. Wastewater from pipe insulation manufacturing activities is pumped to the "black ditch" via underground piping (denoted as "sewer" in Attachment III). The black ditch was so named because the effluent that once entered it was black; however, the ditch is now milky white from the fibrous suspension, composed primarily of calcium and silicate, it contains. The effluent is pumped up from the east end of the ditch to the pond in the southwestern section of the site (see Attachment III). The effluent in the pond flows northward, where it is joined by the paper mill effluent. The paper mill effluent is pumped overhead and enters a canal which flows northeast to the aforementioned pond; the paper mill effluent canal was not observed during the site visit. The combined effluent streams enter the mixing basin, which is a large pond equipped with a series of levees that increase the wastewater retention time. At the north end of the mixing basin, the wastewater enters the northernmost pond which then

A surface runoff pathway exists at the northeast corner of the miscellaneous disposal pit. The eastern wall of the pit is not continuous, and surface runoff from the pit and surrounding areas flows through the opening in the pit (see Attachment III).
